**AES PUERTO RICO, L.P.
Guayama, Puerto Rico**

June 19, 2014 NPDES Enforcement Case Support Inspection Briefing

**José A. Rivera, BSCE
Regional Storm Water Specialist
Caribbean Environmental Protection Division**

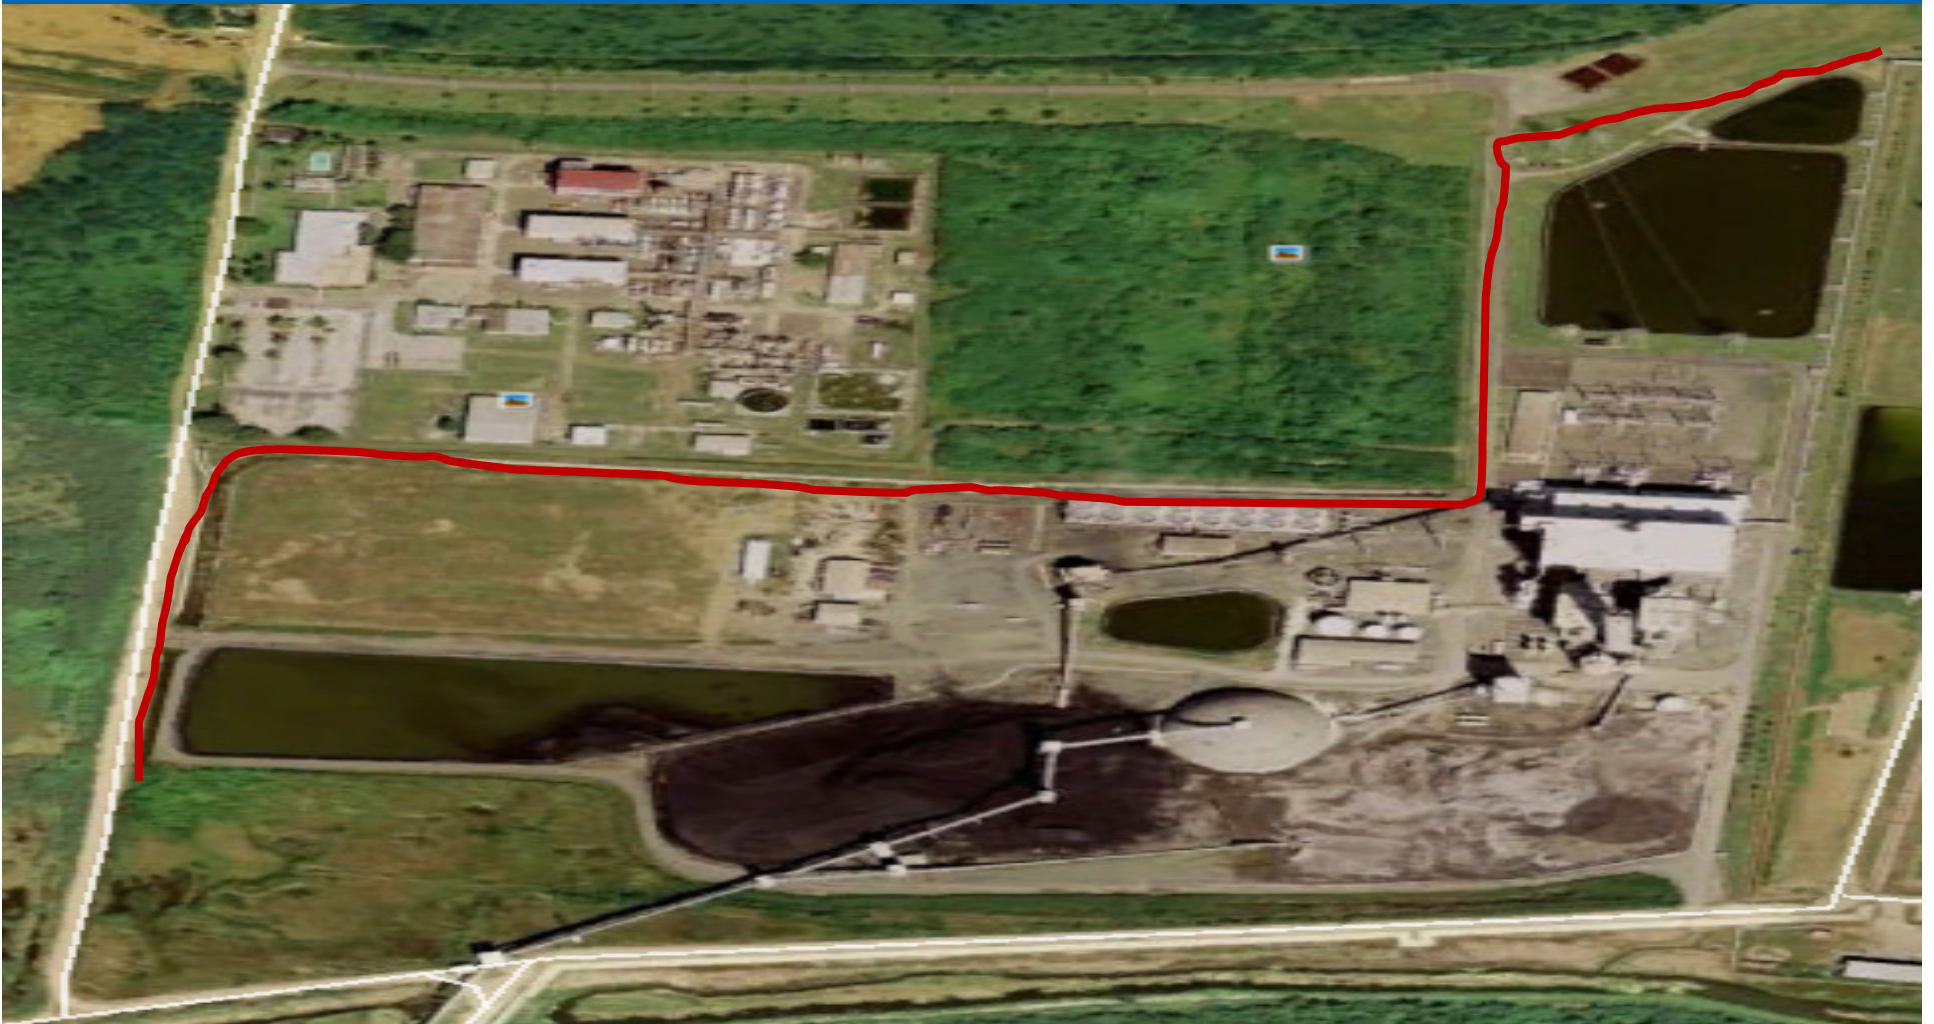
- Run-on from offsite and AES (non-regulated) site collected in concrete channel that discharges into wetlands

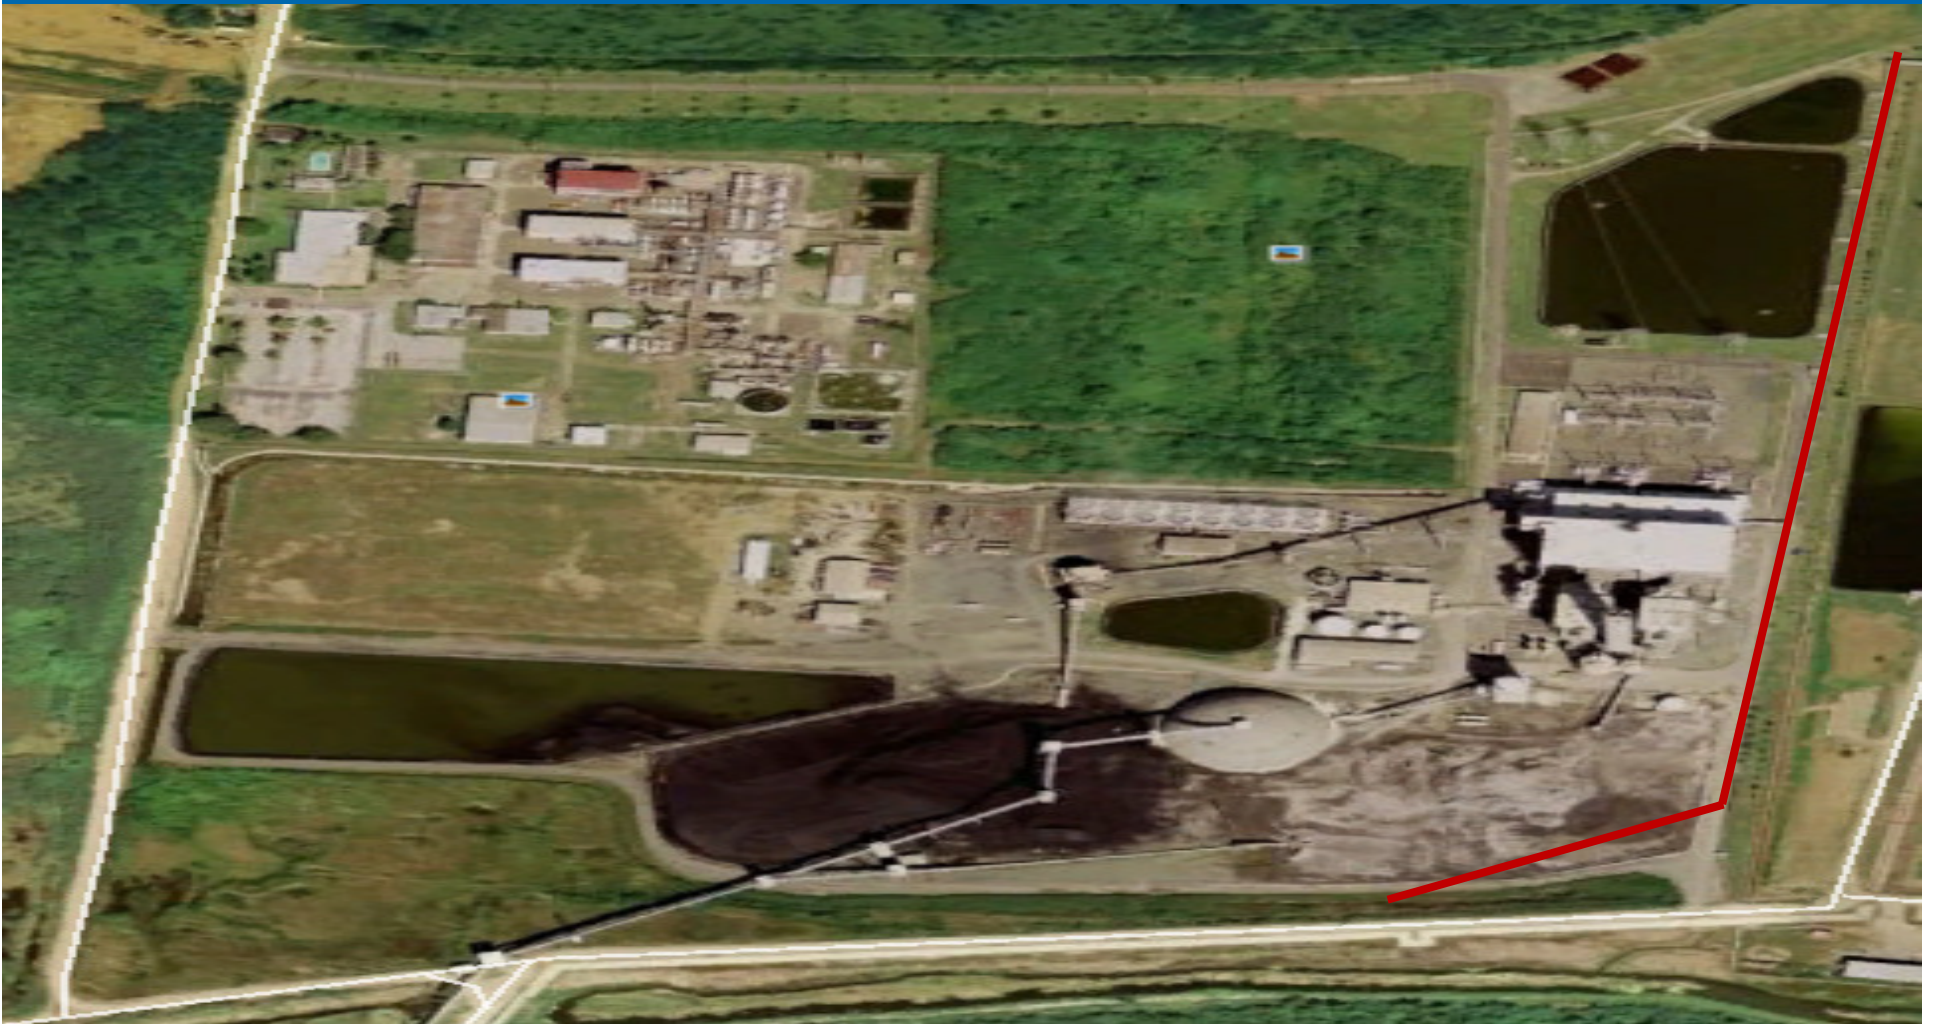
- Run-on from neighboring lands on north side is collected in underground pipeline that discharges into wetlands

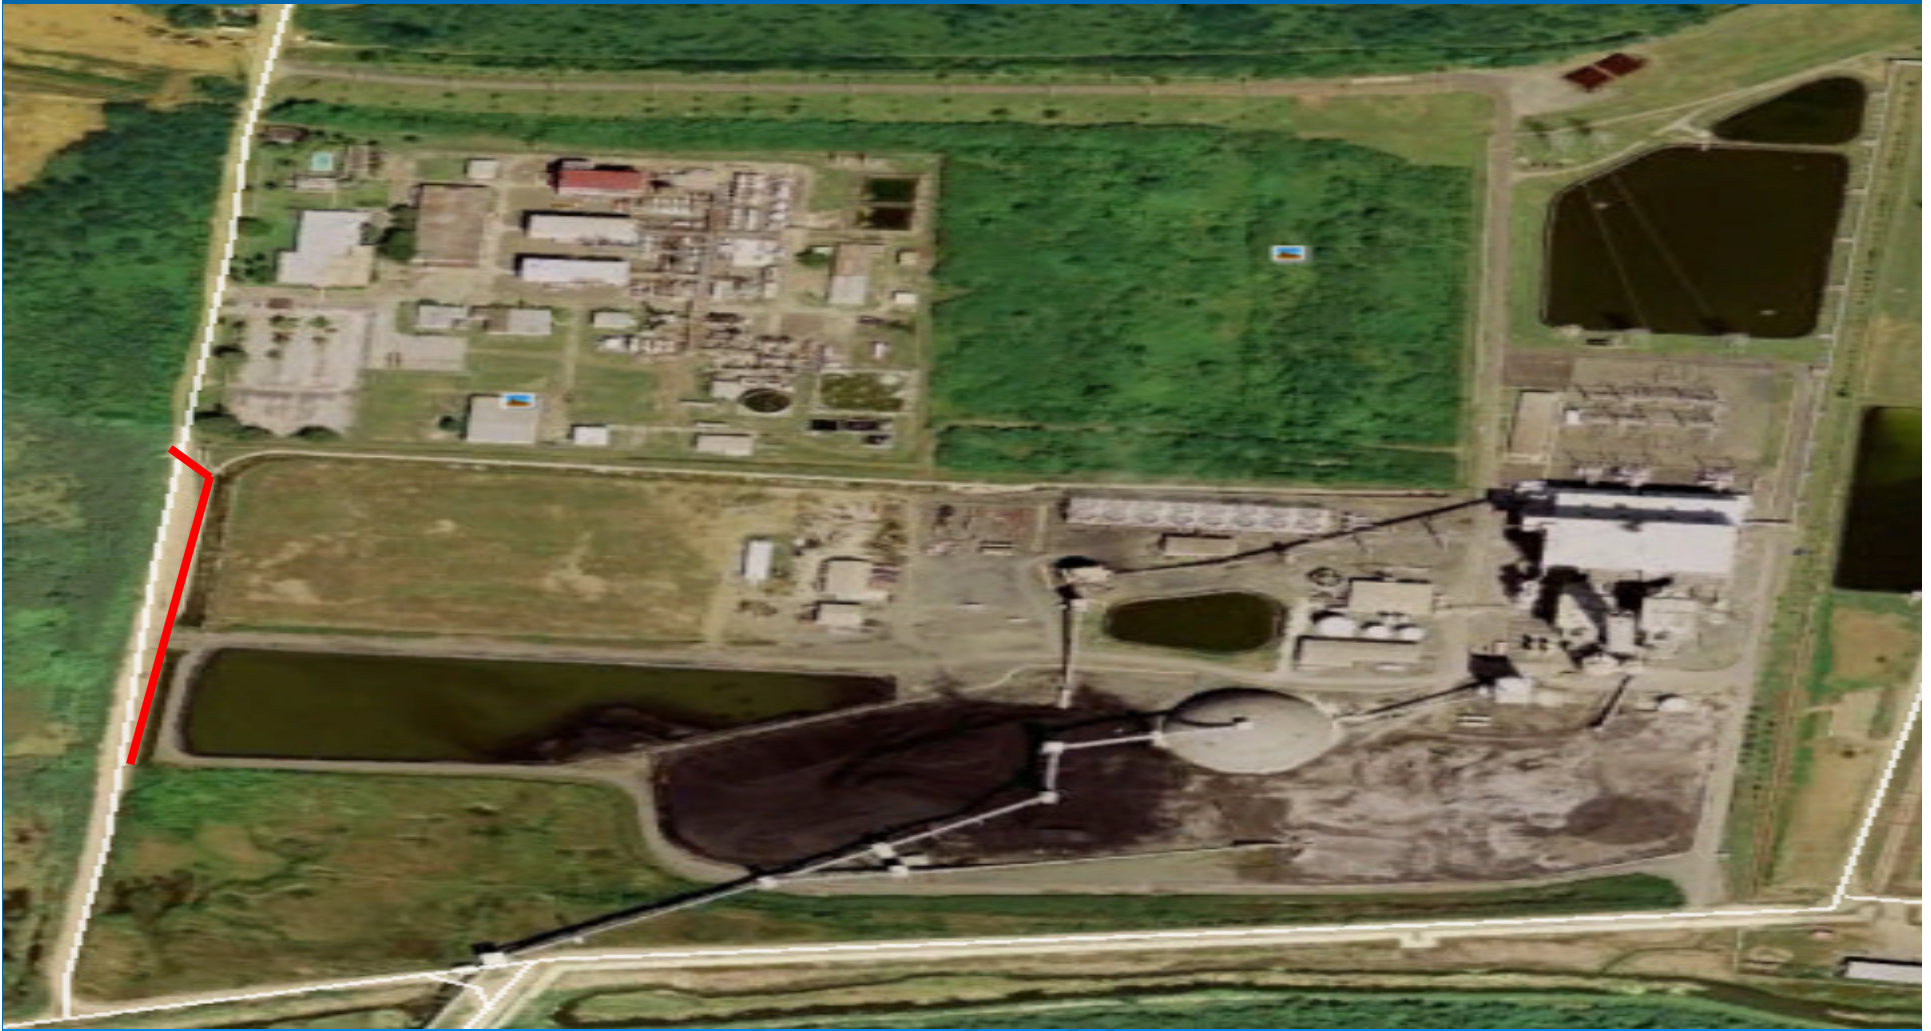
- Run-off from TAPI's facility is collected and discharged into wetlands side-by-side AES's Outfall 003.

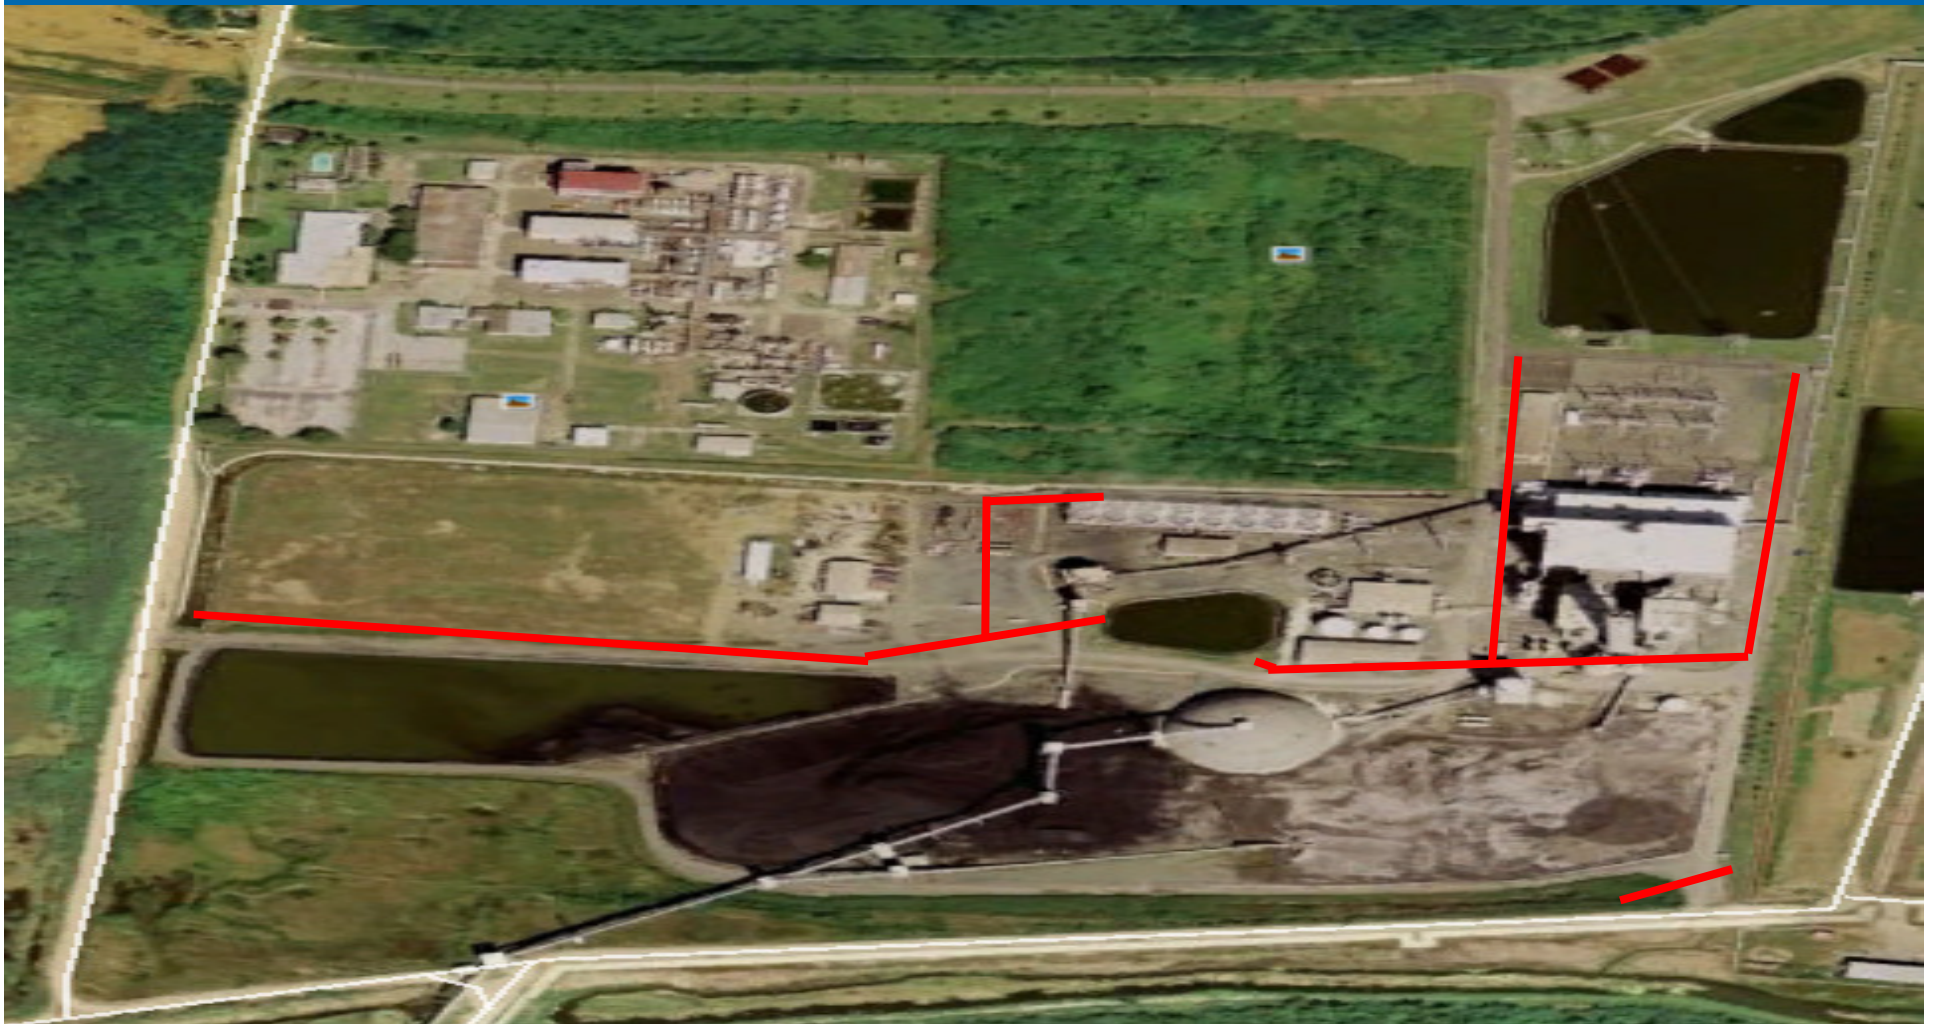
- AES' site stormwater runoff associated with industrial activity is collected in a stormwater collection and discharge system. AES reuses the runoff collected at SW Pond for water production prior to overflow discharge.

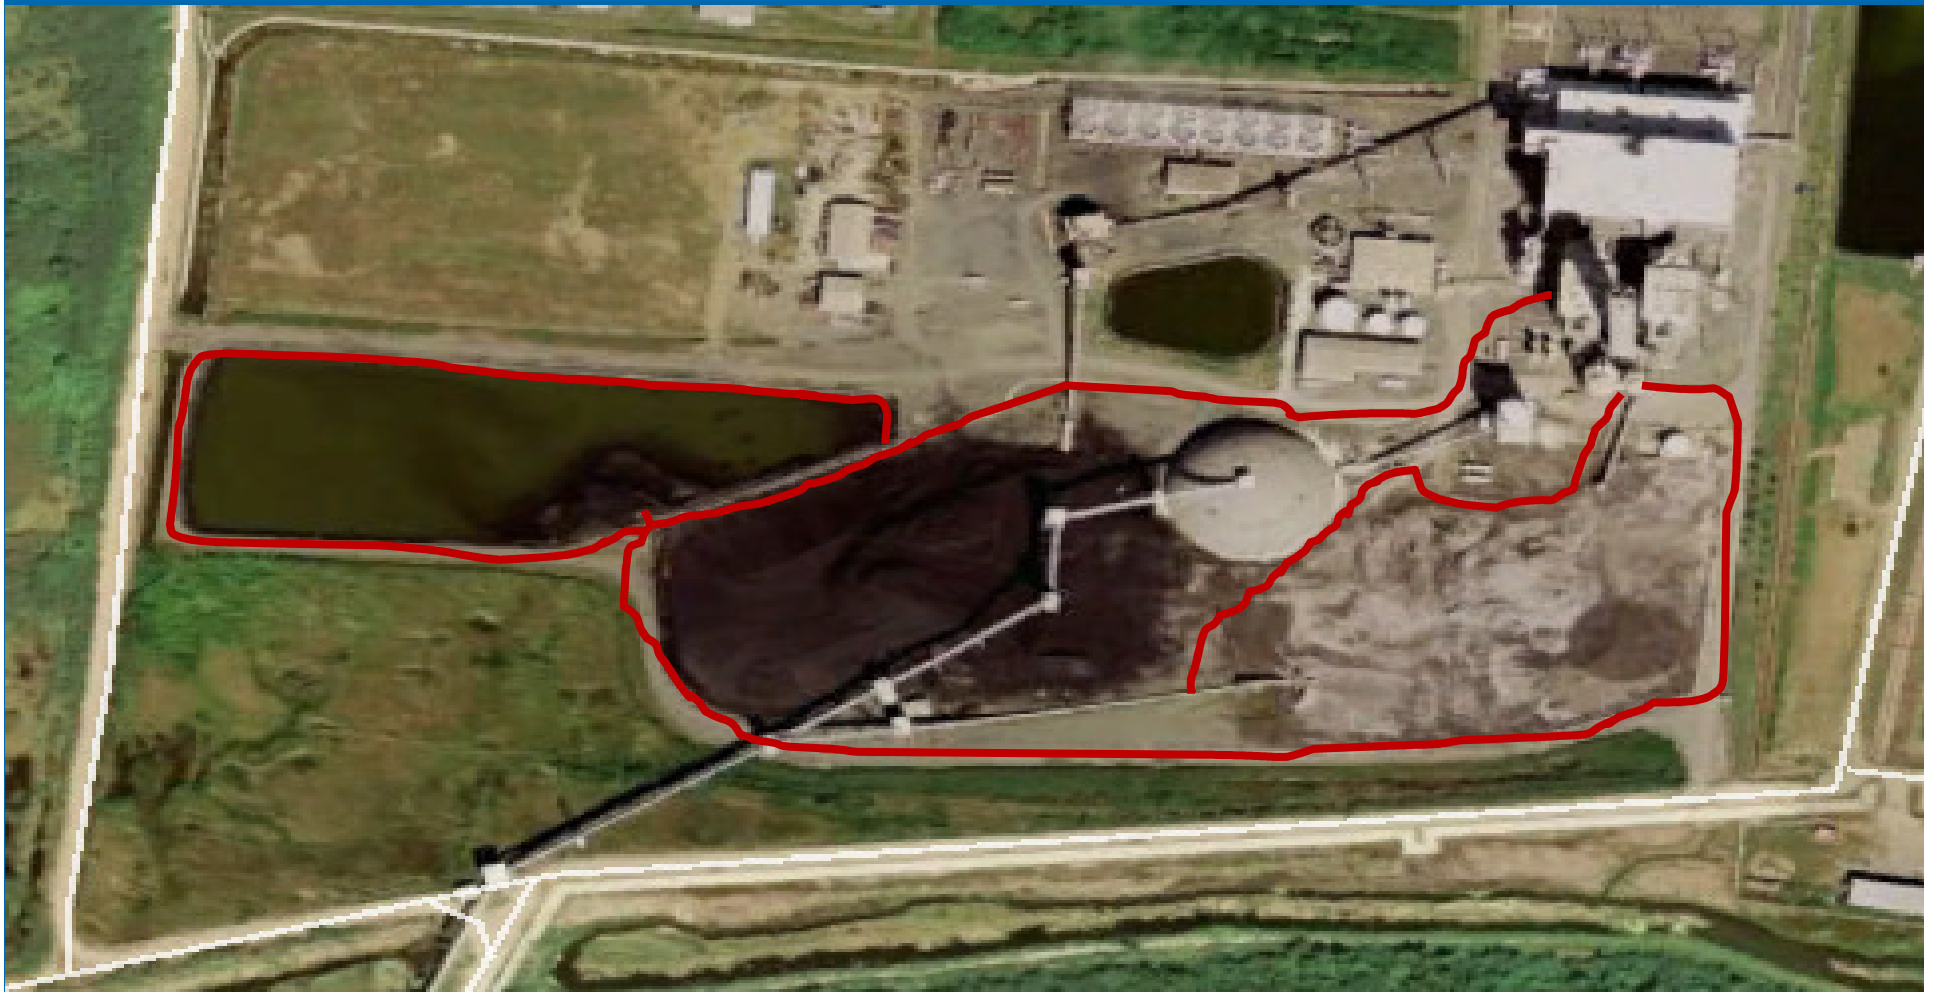
- Run-off (stormwater and process wastewater) from production and material storage areas is collected and conveyed into Coal Pile Runoff Pond through swales and channels. No discharge from this Pond into wetlands. All wastewater is re-used for water production and dust control.

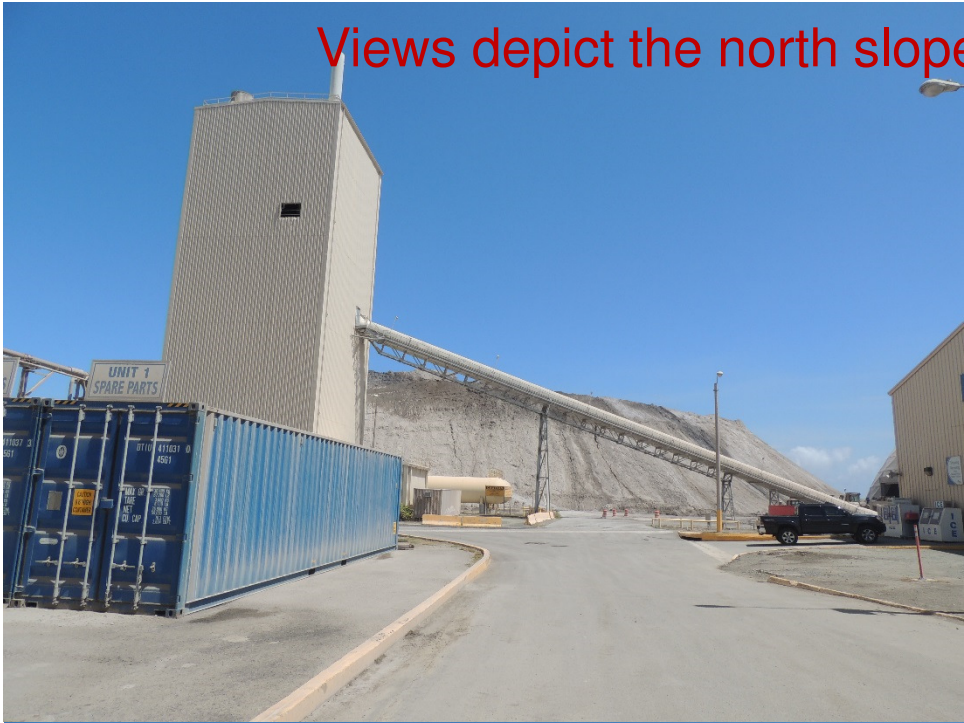
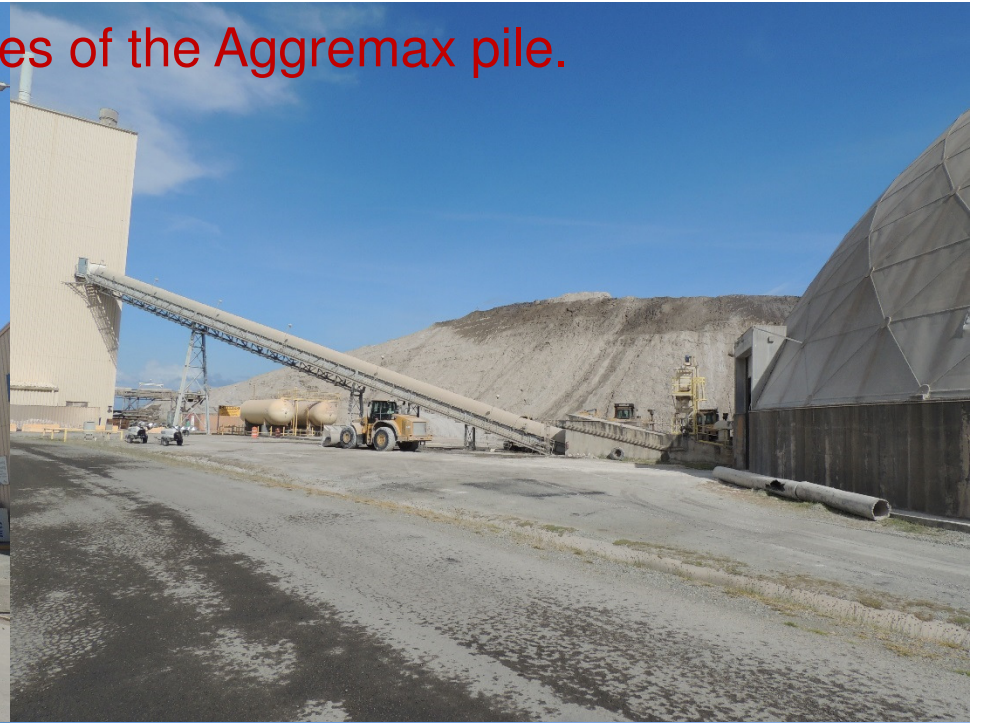
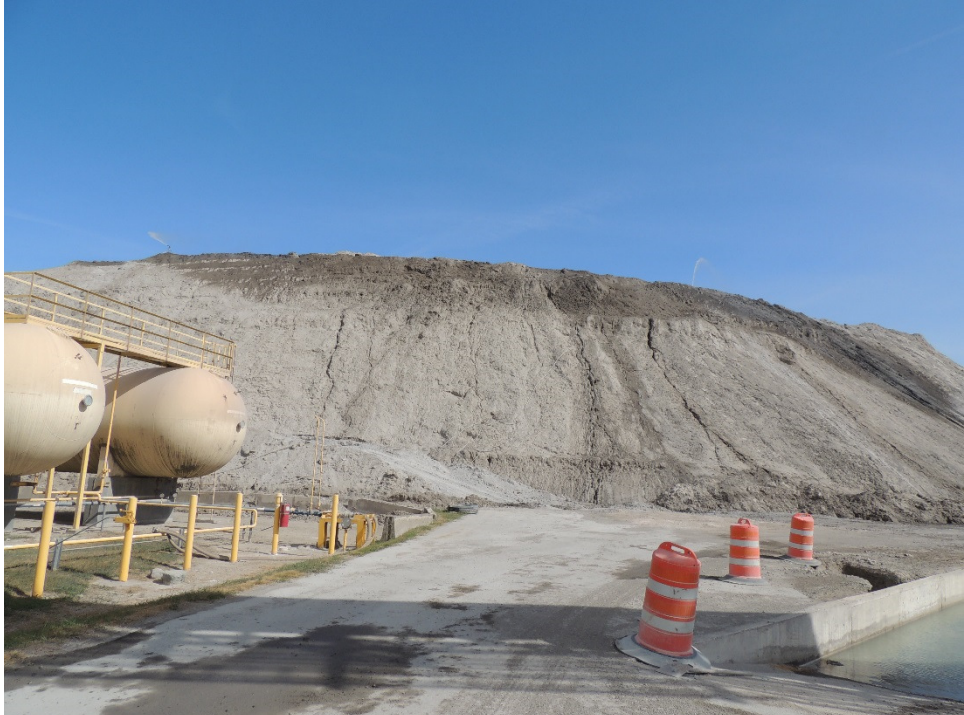
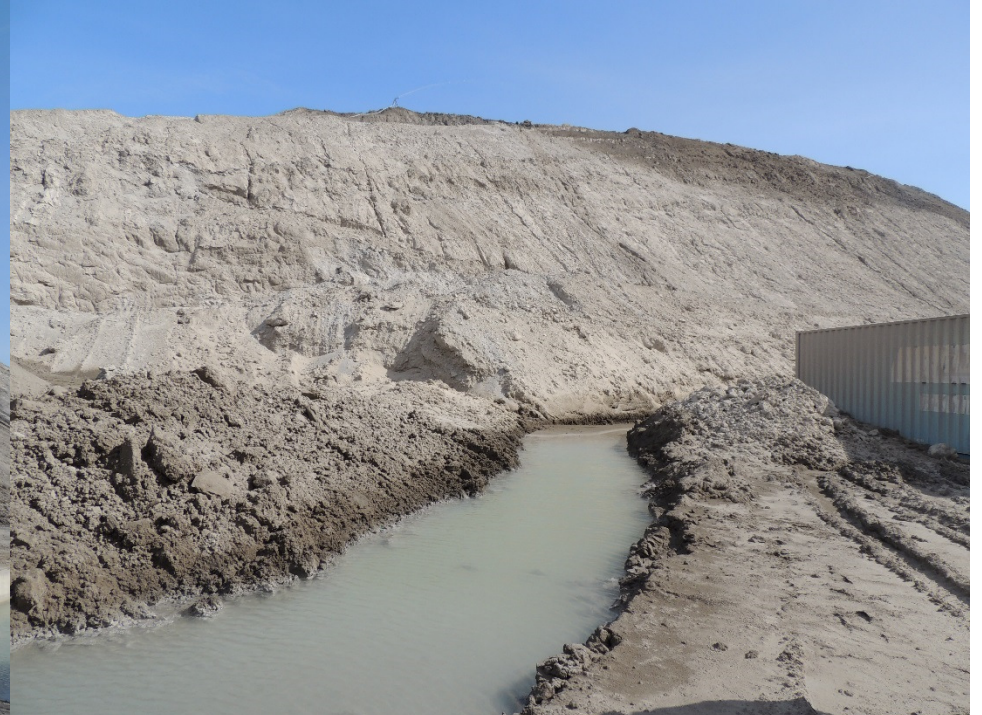
Views depict the north slopes of the Aggremax pile.

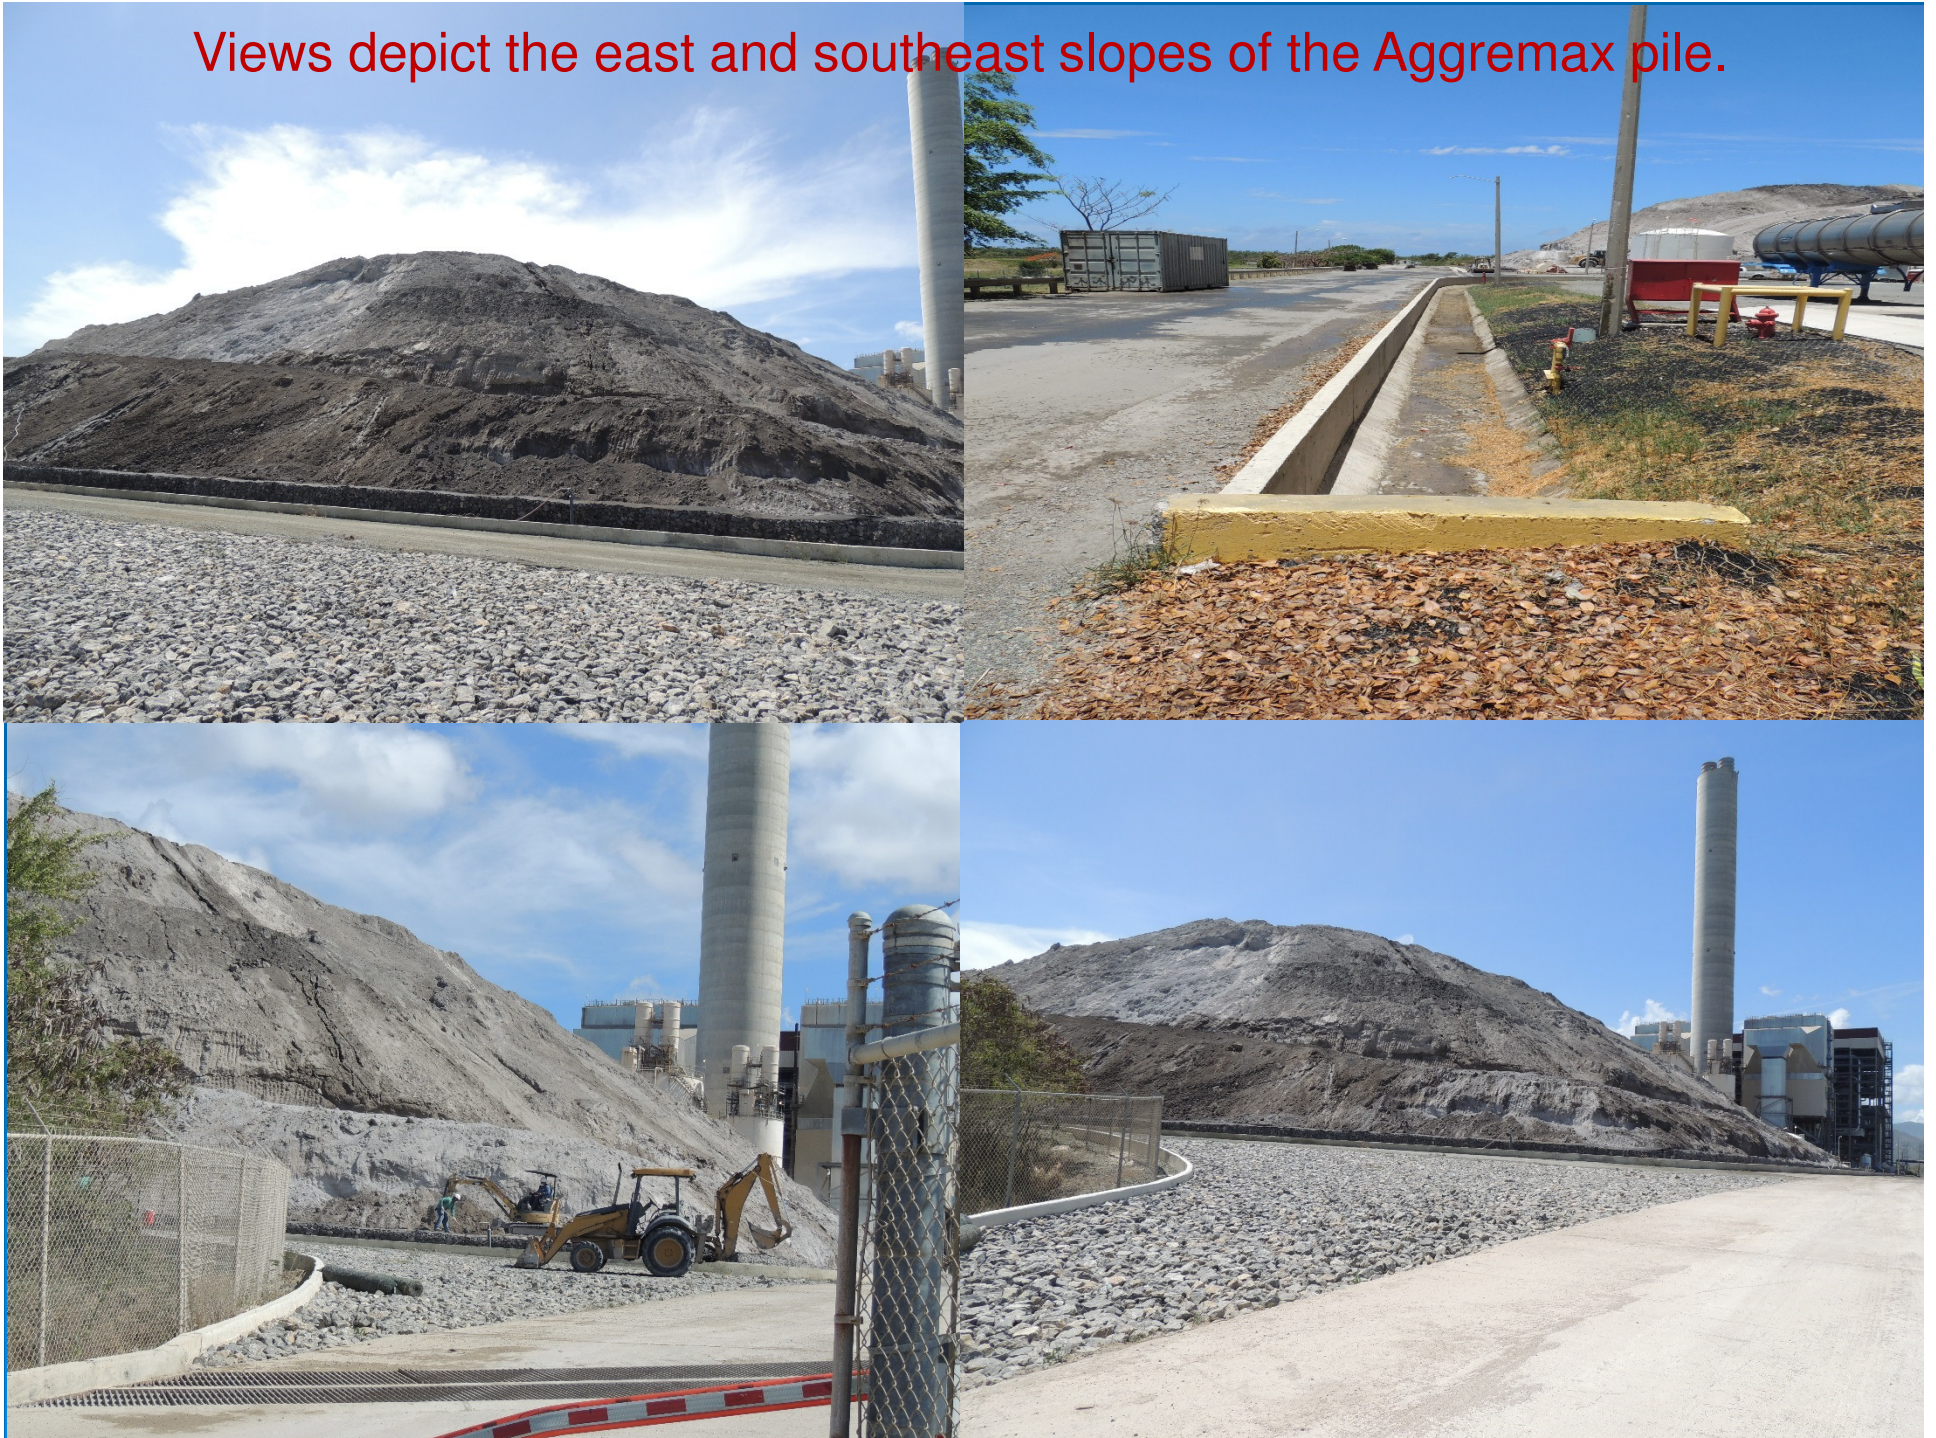
Views depict the east and southeast slopes of the Aggremax pile.

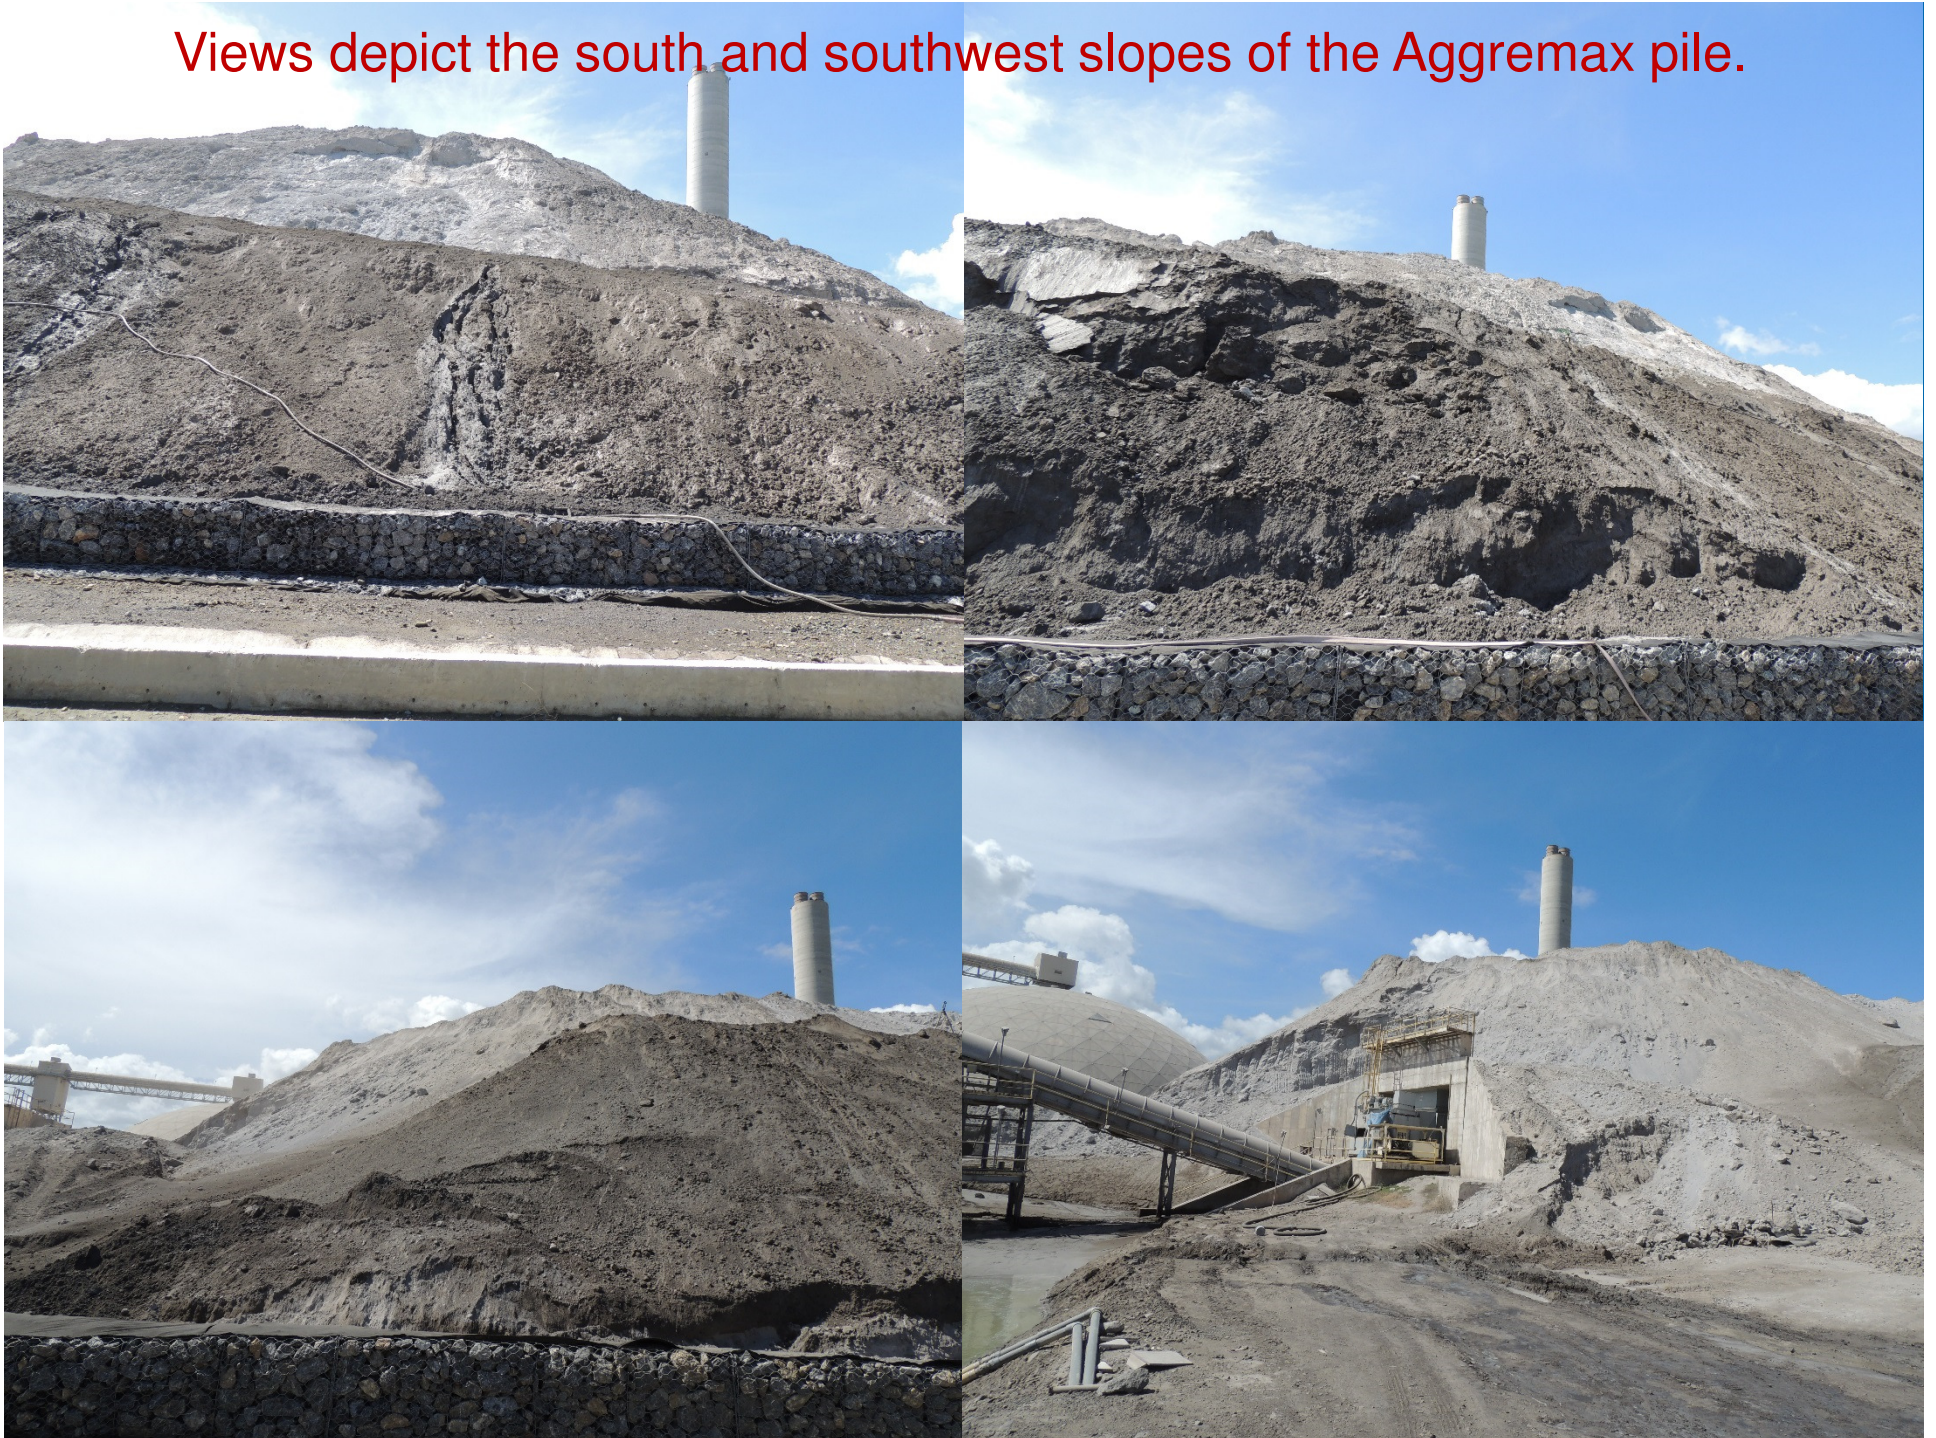
Views depict the south and southwest slopes of the Aggremax pile.

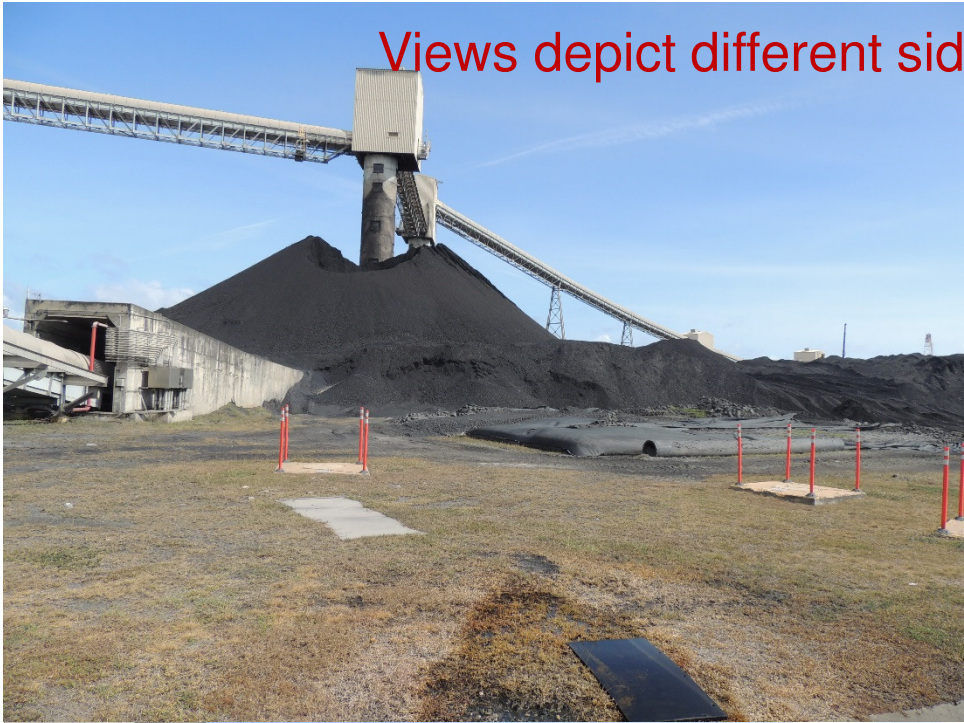
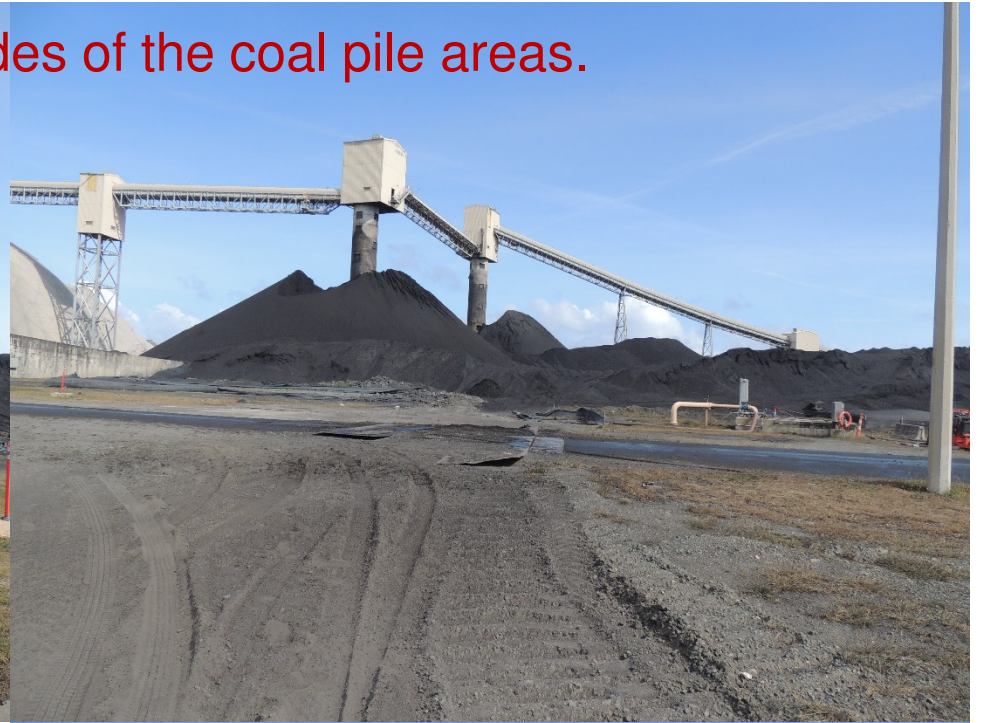
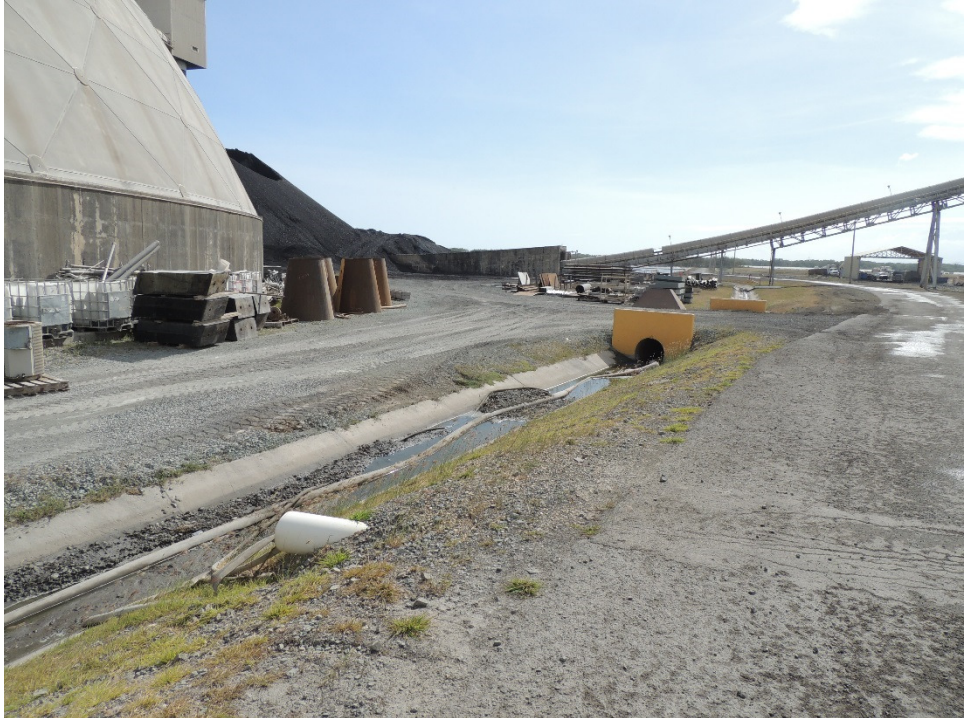
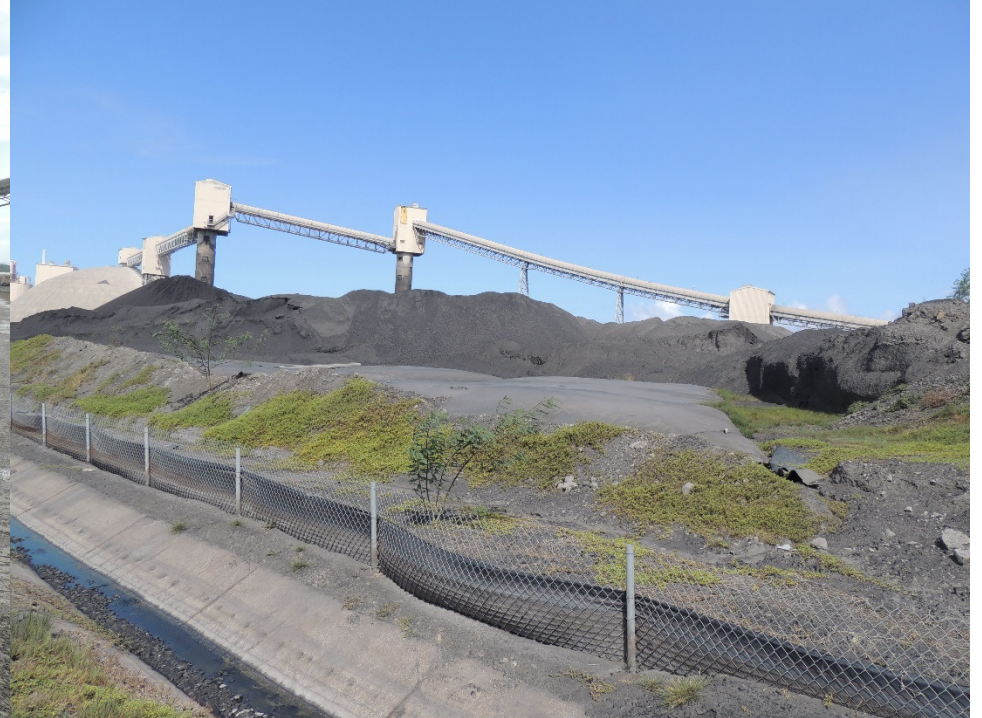
Views depict different sides of the coal pile areas.
